## Why the radio reception is poor

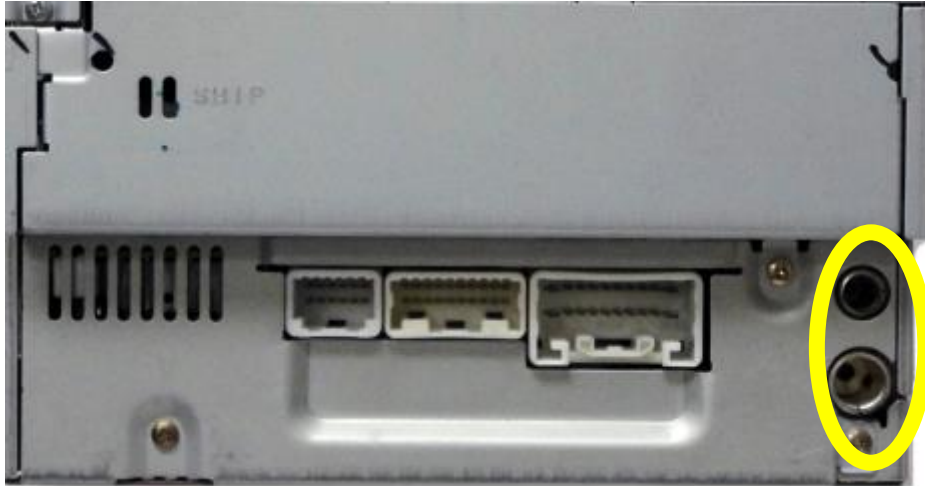
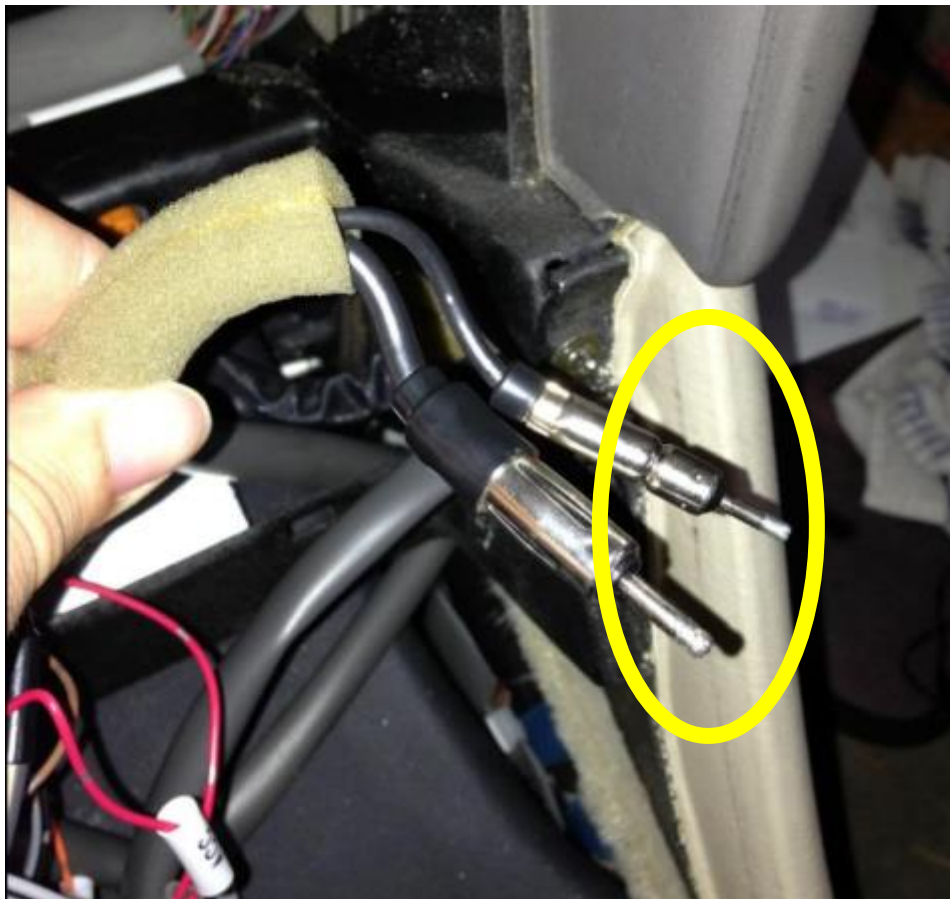
Because the factory unit has a diversity system to choose the antenna with better reception, it has two radio antenna plugs. See below photos:

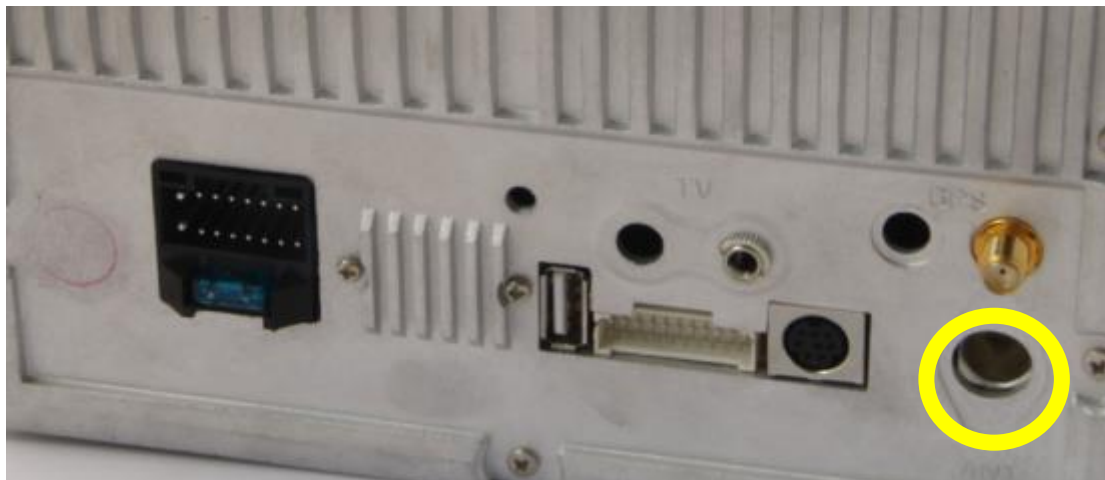
But all aftermarket head units(include Kenwood, JBL, Pioneer, JVC etc.) only have one standard ISO radio plug, see below photo:

So the diversity system is invalid if only connects one radio antenna to the aftermarket head unit and cause the reception is poor.

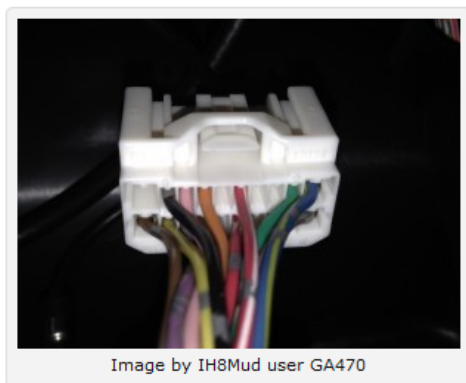
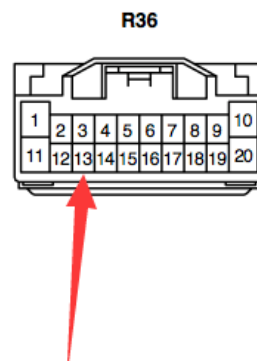
The 20 Pin looks similar to the LC connector (R36) but the pins are out in another order.

**Item 2. Connect the radio antenna system power wire to +12V. See below photo, pin 13 is the power wire.**
